terrane**ts** bw
GmbH

Degaussing pipelines with the Degauss 600

EWM technology being used on terranets bw GmbH building sites

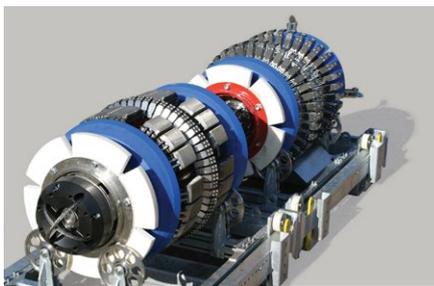
Intelligent pipeline pig for inspecting the condition of high-pressure gas lines

High-pressure gas lines are inspected using “intelligent pigging” to ensure their integrity.

A pig is a cylindrical device made up of several disks, which are sealed against the pipe wall with cups. It is transported through the line using the differential pressure within the pipe. Pigs are 6 to 10 m long with feed rates between 1 and 5 m/s.

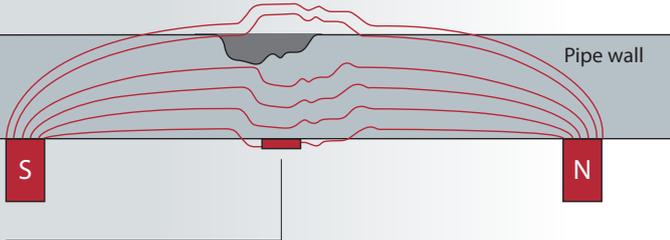
Magnetic flux leakage procedure schematic

A strong magnetic field is applied parallel to the pipe wall. The magnetic flux lines are deflected if:

- there is material loss within the pipe wall.
- there is magnetisable material near the pipe wall.
- the pipe material’s properties change.

The pipe’s wall thickness is measured using the magnetic flux leakage procedure. This procedure requires strong,

ring-shaped magnets attached to the pig, and the magnetic flux lines are immediately registered via sensors. These recorded signals are then compared with reference signals. Any deviations in the recorded signals can help to identify potential areas of material loss or ovality. As intelligent pigs are equipped with systems for determining the distance covered, the position of the findings can be identified. The downside to this method, though, is that the pipelines being

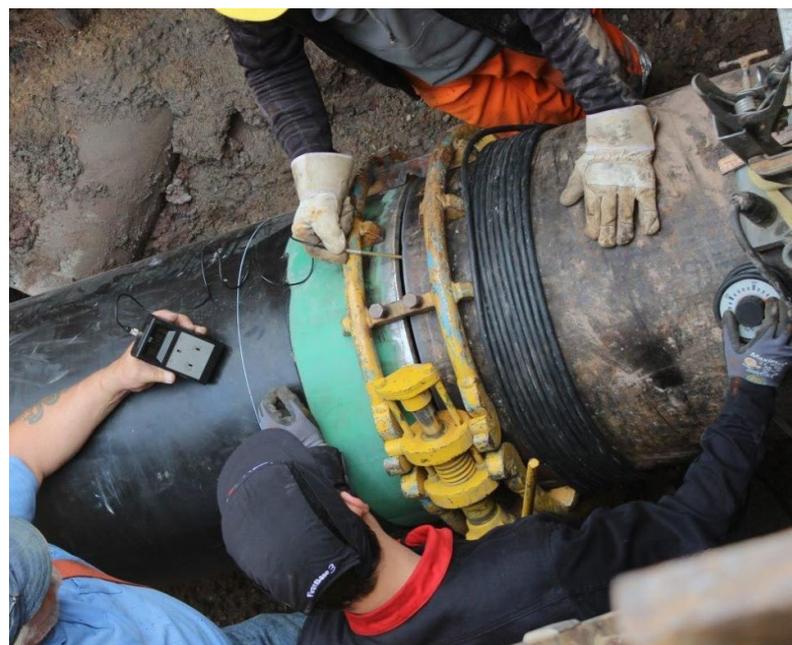
Measuring the field strength right before welding. The new pipe section was not degaussed.

Before inserting the new pipe section with a diameter of 600 mm and a wall thickness of 10 mm, the residual magnetism was measured at the welding joint using a field strength meter. The values were between 2 and 5 mT along the pipe circumference. From experience, EWM AG assessed that these values were below the range in which one can weld with an electrode. So it was determined that it was highly likely that no degaussing would be required for

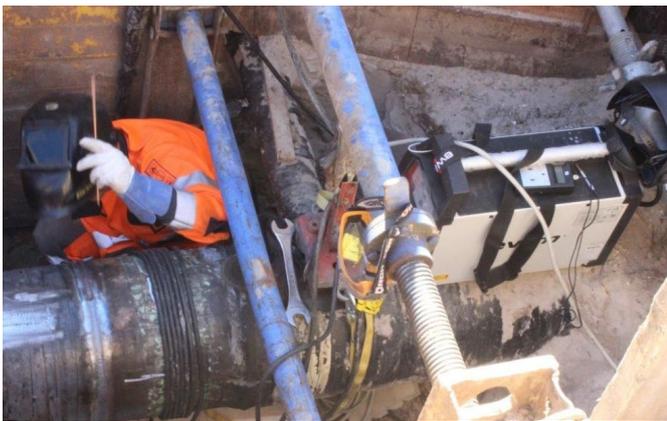
Successful TIG welding on a flange between a pipe section and a ball valve

Here, the old gate valve of a high-pressure gas line should be replaced. As the welding joint was situated near the gate valve, MMA welding was not feasible; the ball valve's sealing surfaces would have been damaged by unavoidable spatter on the inside of the pipe. Instead, engineers opted for the TIG welding procedure. TIG welding, however, is much more sensitive to magnetisation than MMA welding and the magnetic fields have to be completely eliminated.

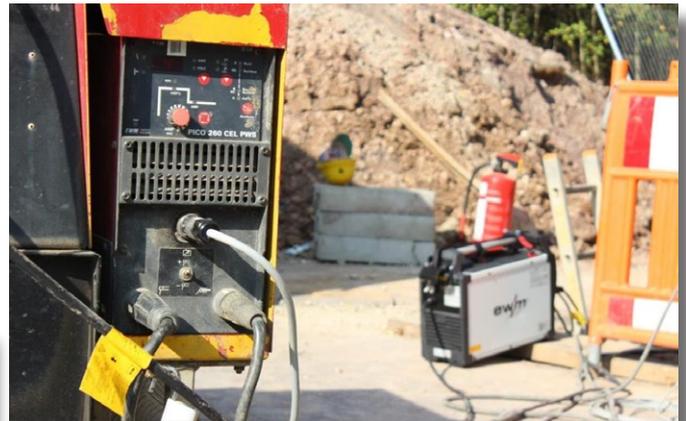
The dream team: EWM power source PICO 260 CEL PWS and the Degauss 600 (in the background)
